The Relocation of Peyton Slough: A Unique Solution to a Water Quality Quandary

Lead Agency – San Francisco Bay Water Board Lindsay Whalin*

Responsible Party - Rhodia Inc.

Project Summary

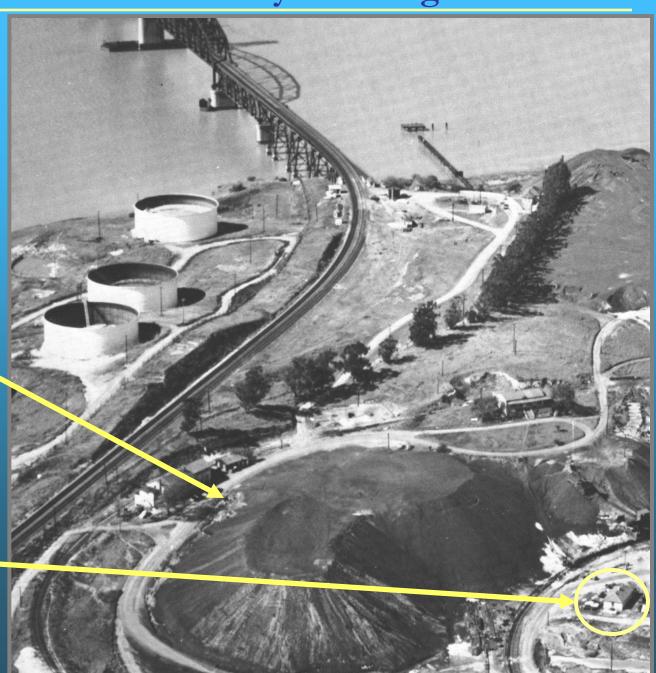
Tailings Piles

Site History Mountain Copper Company operated a copper ore processing facility on site from 1899-1966. Tailing (waste rock) piles were so massive they subsided up to 40 ft below the ground surface into Bay Mud

Scale of tailings piles

Massive tailings pile

Car next to building

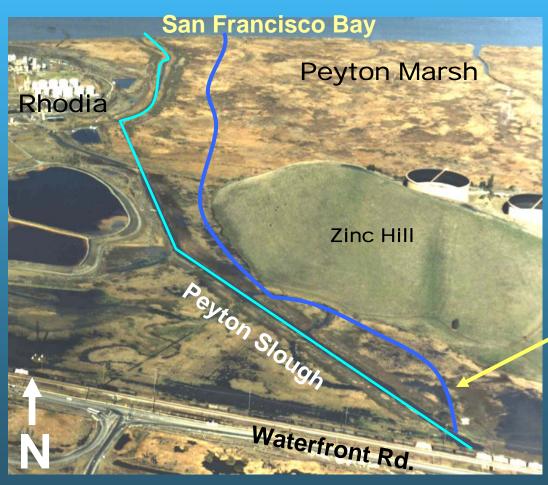
Remediation Strategy

Relocated the Slough east (dark blue) within the marsh and capped the old, contaminated alignment (light blue).

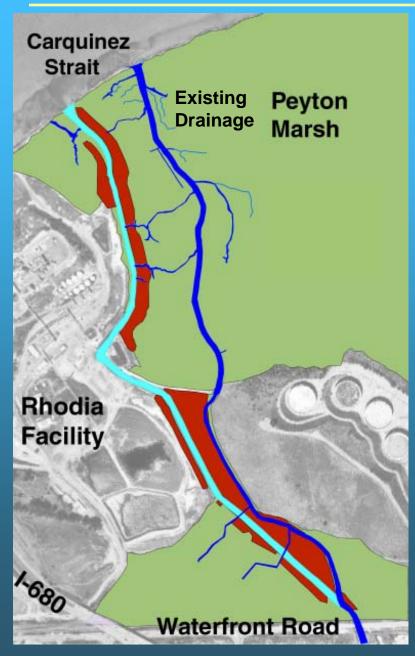
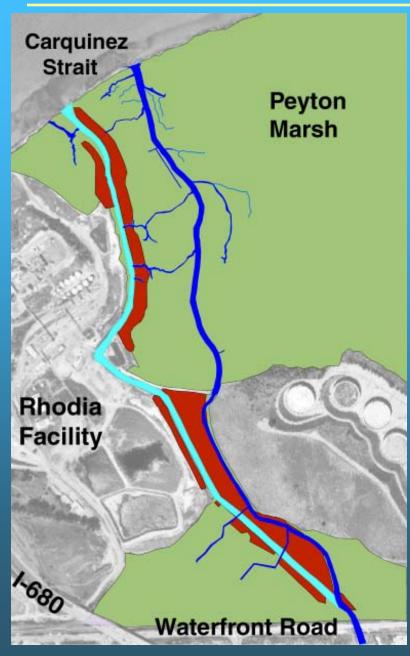
Step by Step Summary of Remediation Approach

1. Excavated new alignment using an already existing drainage.

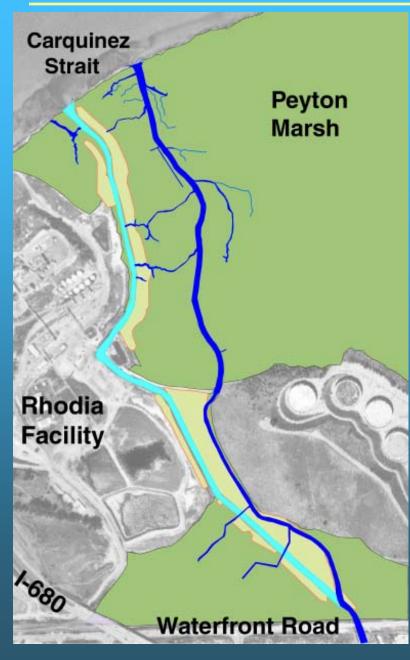
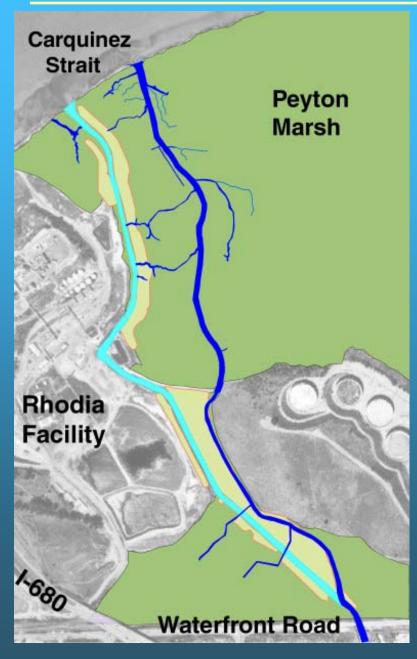
- 1. Excavated new alignment using an already existing drainage.
- 2. Removed dredge spoil piles (red).

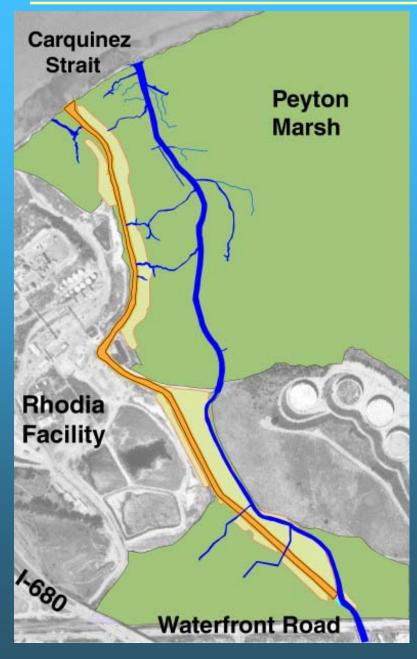
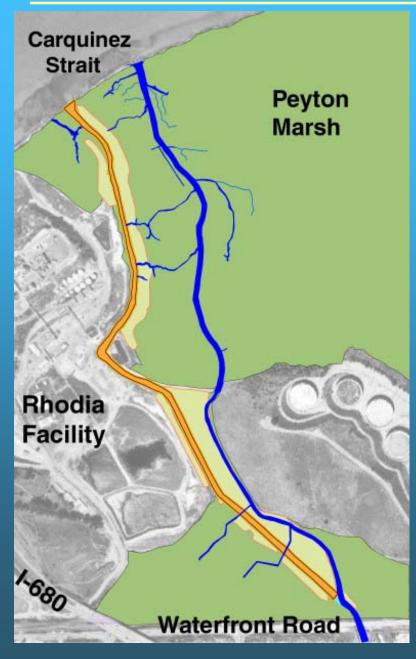
- 1. Excavated new alignment using an already existing drainage.
- 2. Removed dredge spoil piles (red).
- 3. Capped existing slough (orange).

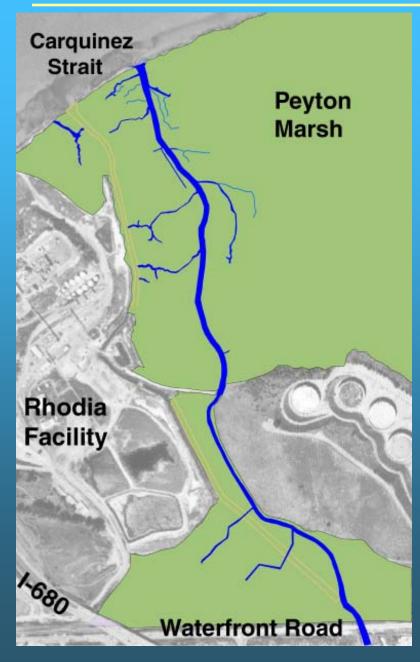
- 1. Excavated new alignment using an already existing drainage.
- 2. Removed dredge spoil piles (red).
- 3. Capped existing slough (orange).
- 4. Restored impacted areas to wetlands.

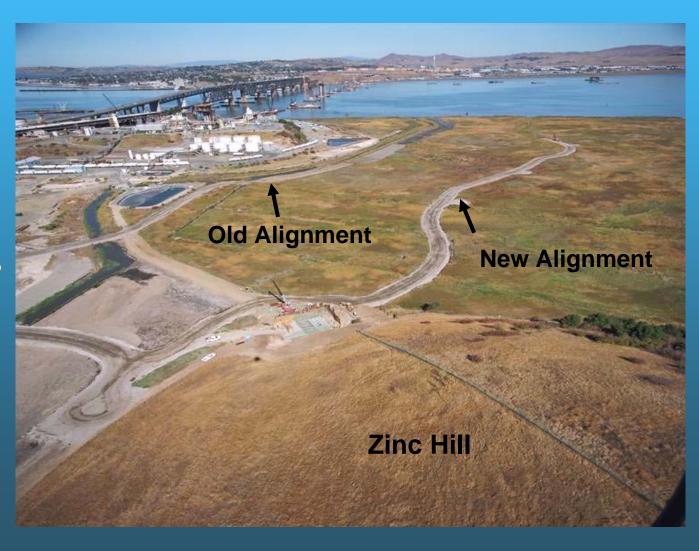
A road was built where the new slough alignment was excavated

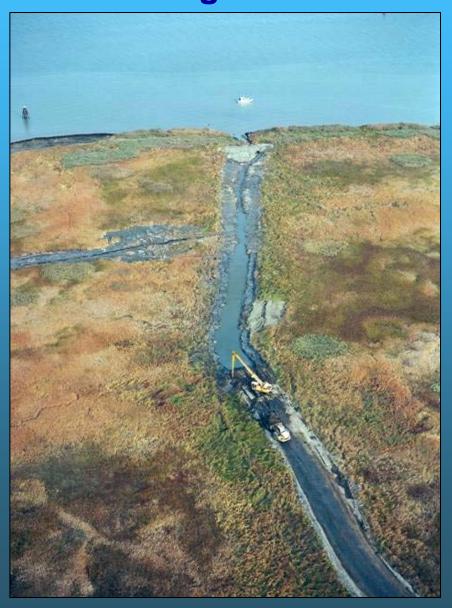
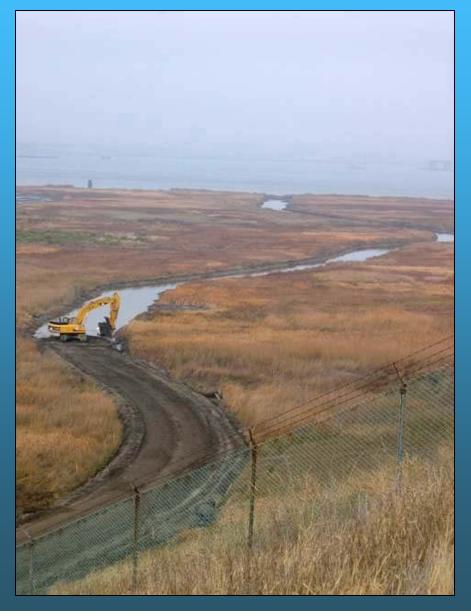
The new alignment was back excavated from the road

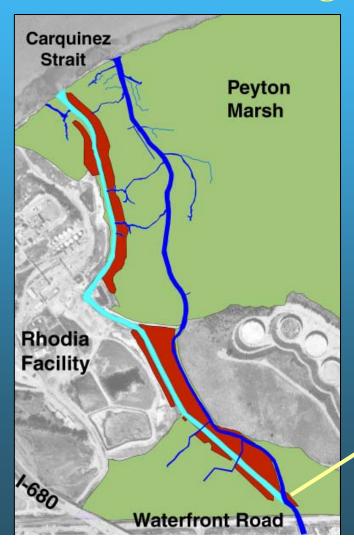
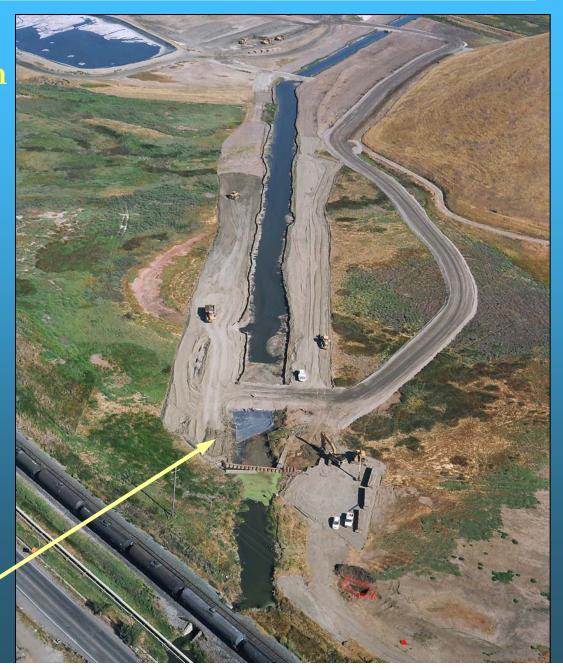
Transition point from old to new Slough

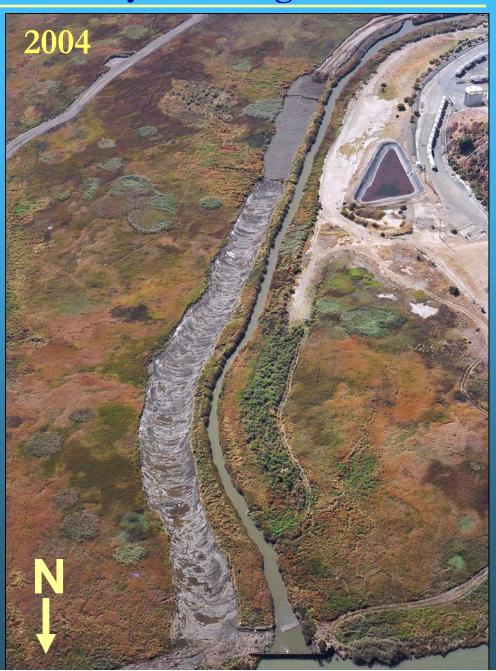
Excavated dredge spoil piles from the banks of old slough

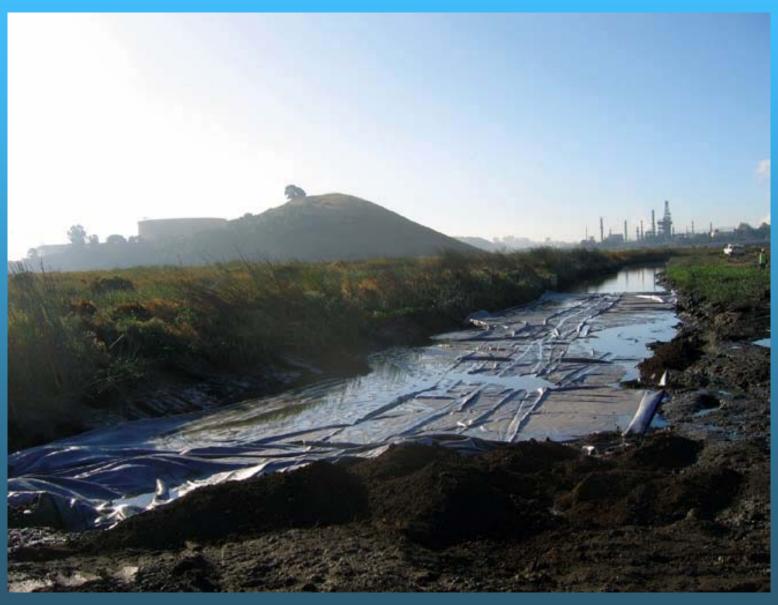
The Old Alignment was Capped August 2005

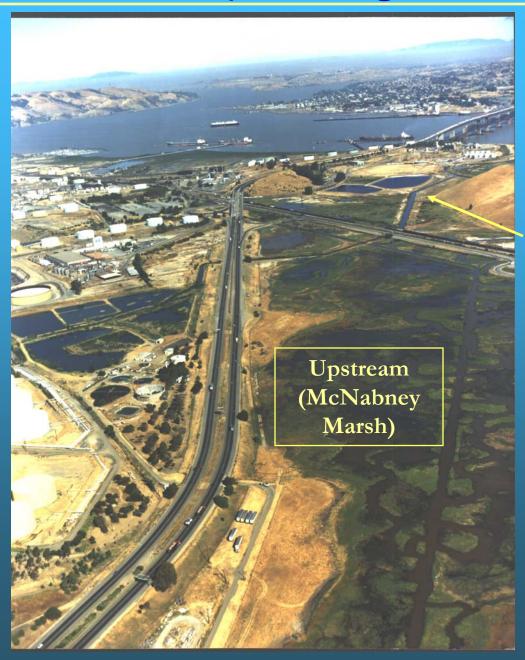
Tide Gate

The tide gate on the old alignment could only be operated to allow upstream marshes to drain into Peyton Slough. Tidal waters could not flow upstream of the tide gate because scouring of the slough bottom would create contamination upstream. This problem no longer exists with the new alignment tide gate.

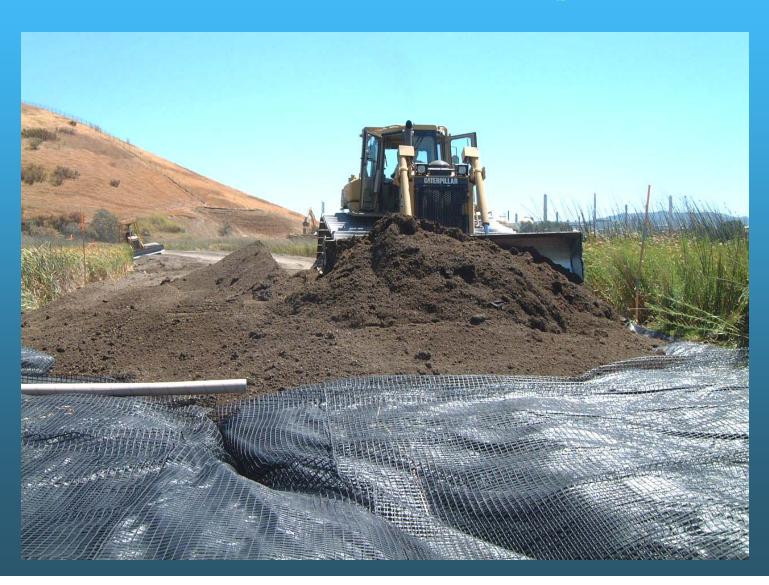
Project Challenges Designed a temporary road over soft soils in marsh to minimize impacts to marsh habitat

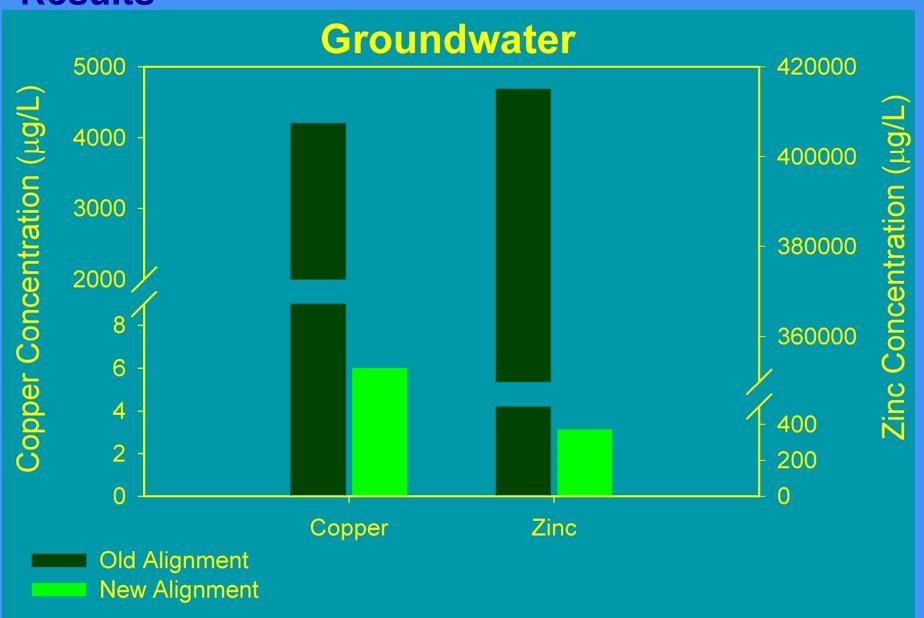
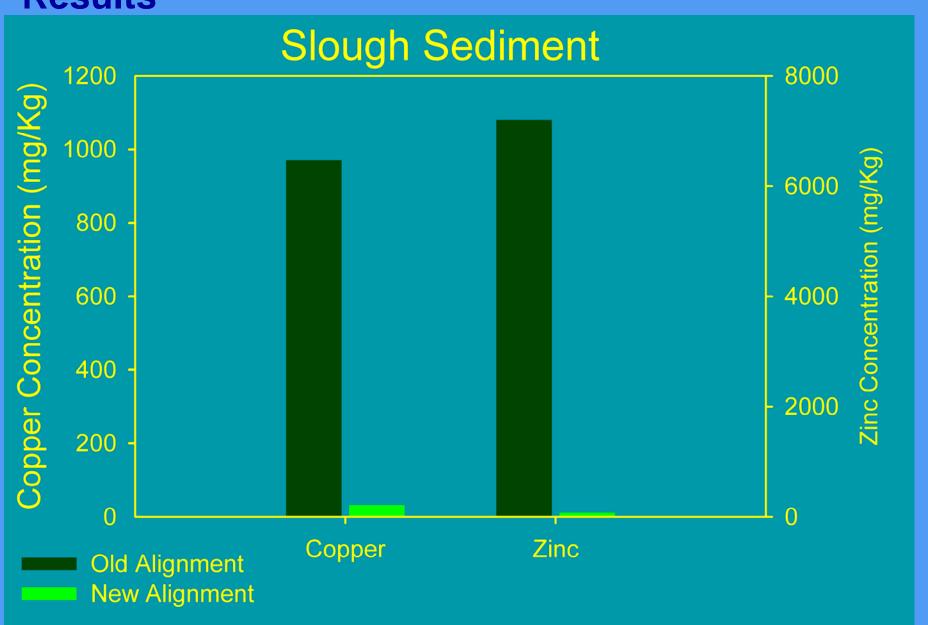
Monitor Copper, Zinc, & pH for 10 years

- ♦ 9 well pairs along new slough alignment

♦ 5 stations within new alignment

▲ 4 locations in new alignment

9 transects

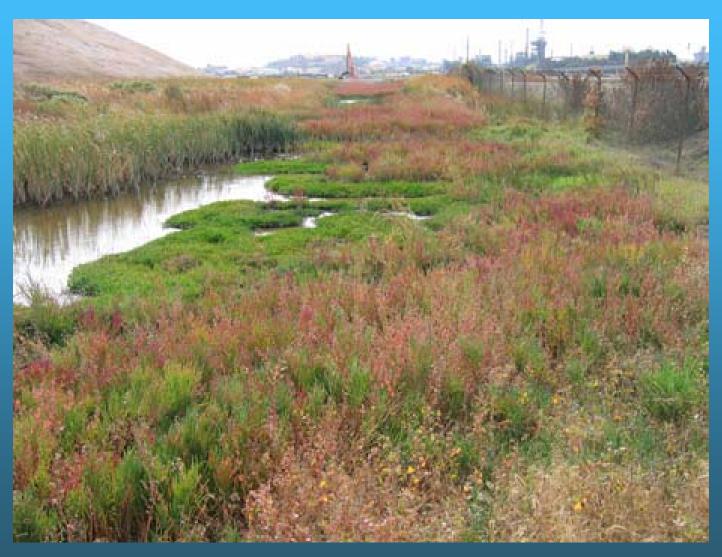
5.46 acres of new wetlands were created
